## The Modification of Morris Mini Minors and Austin Se7ens in Scandinavia in 1960

**Introduction.** R.G. (Bob) Seymour became a Service Engineer for Nuffield Exports Ltd. in 1958. Bob spent seven weeks in Scandinavia during the Spring of 1960 and the following are his recollections of the modifications that were carried out on Morris Mini Minors and Austin Se7ens (ADO 15s) at that time.

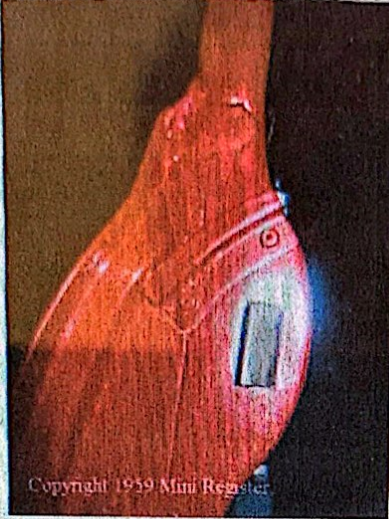
Mid 1950 door showing the lock protector still riveted in place but the drain hole is now through the conventional rubber hose through the bottom of the door. The deflector would later be incorporated in to the door moulding rather than riveted on separately.

3) Fitting rain water diversion plates above the door locks on the closed part of the doors.

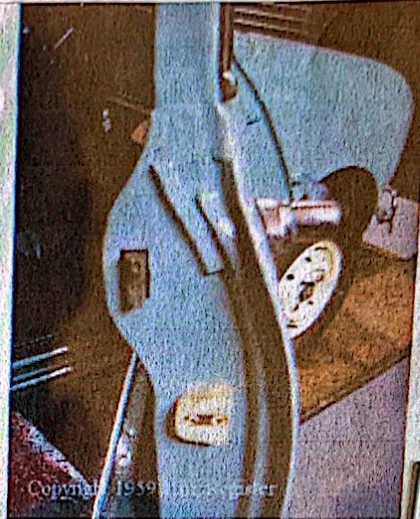
Later Mk1 style door showing the water deflector plate as part of the door pressing.

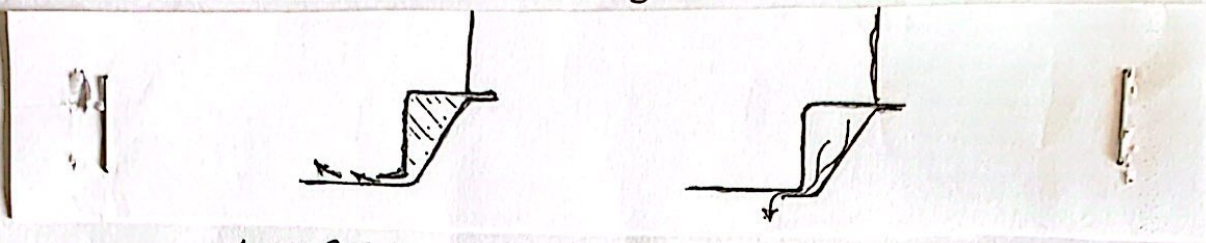
IMAGE 1

5) Sealing of the welded joints on the underside of the body to prevent rain water entry into the car.\* The floor pressing and its reinforcement had been designed the 'wrong way round' which allowed rain water to enter the car between the spot welded joints – see image 1. The expensive correction, which was introduced on later cars, involved a

redesign of the floor pressing and placing the reinforcement internally so that rain water could exit under the car – see image 2.
